## Up on the Roof.....Fire Prevention BY David Laks, P. Eng., CFPS, ARM, RRC

Every year there are a significant number of roof fires resulting from installation, neglected maintenance, or housekeeping. This article discusses how the design, installation, and maintenance of roof systems impact the likelihood and severity of roof fires. Case studies will be included to demonstrate how those three elements affect roof fires.

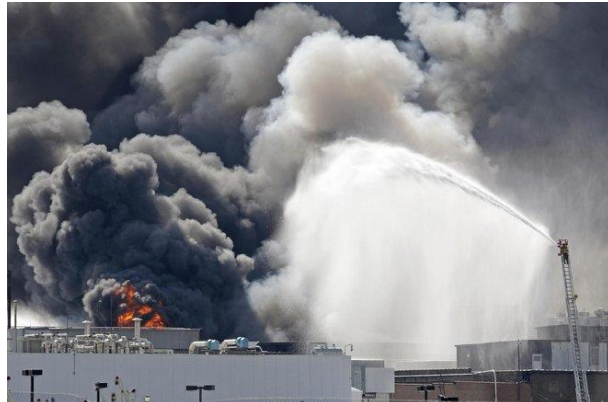
On July 5, 2009 a U.S. Navy reservist launched a stolen military flare that ignited a plant roof in Cudahy, WI. This resulted in a property and business interruption loss of \$318 million (U.S.), of which \$118M was uninsured. Insurance companies and the plant owner (Smithfield Foods) sued the U.S. Navy for negligence and **won** (pending judgement between \$51MM and \$188MM).

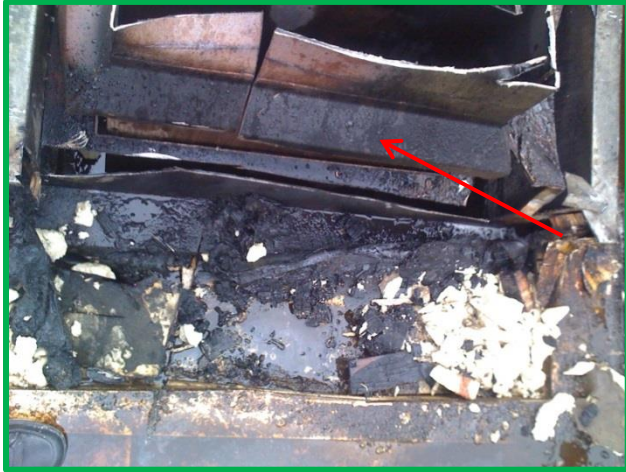
The photo below shows a hot stack through-roof penetration that was not properly designed (i.e. without non-combustible insulation separating wood support blocking). Over time, the wood blocking dried out and was ignited by the heat from the hot stack.

Arrow pointing to wood blocking around hot ductwork

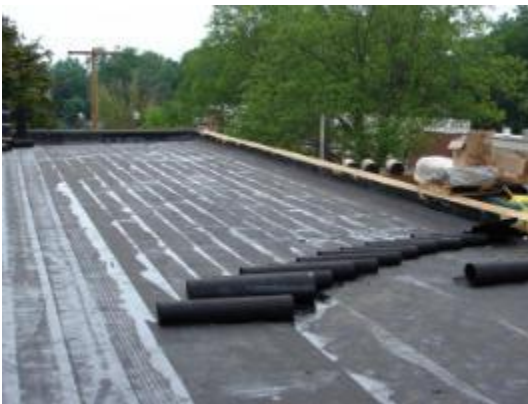
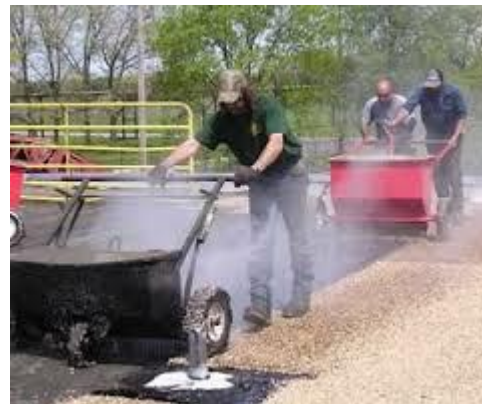
BURs are usually applied in “shingle” fashion using 3-4 plies with felts that are hot asphalt/tar or cold adhesives. They can be finished with a top coat and gravel, or smooth finished (painted). The bitumen (asphalt or coal tar) is heated in kettles and applied with mops or spreaders on the roof.

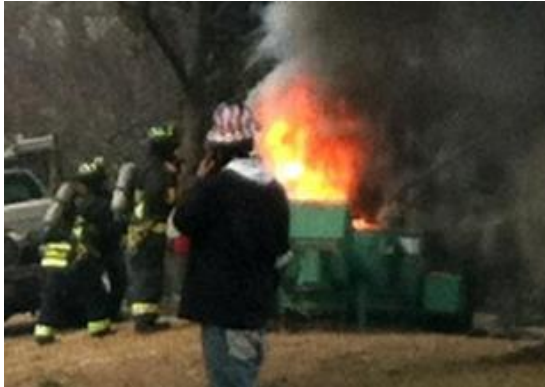
A heat source such as propane or natural gas is used to heat/liquefy the bitumen in the kettle to proper application temperature. This process also releases flammable vapors. The bitumen can also be heated to its flashpoint so precautions must be employed by properly trained personnel.

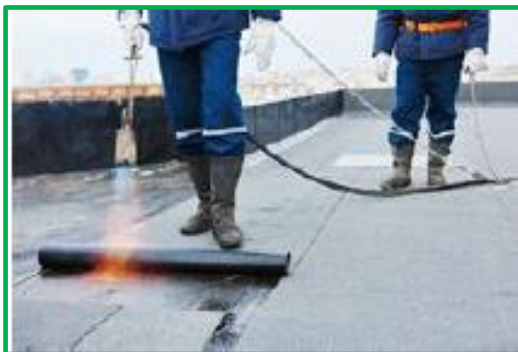
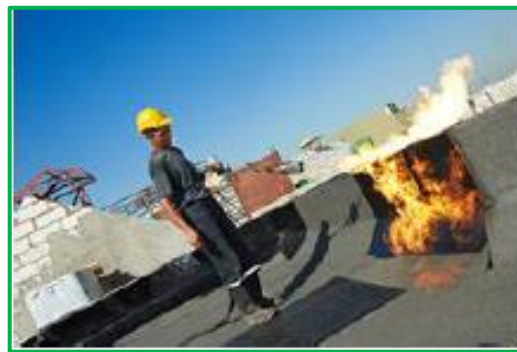
Modified Bitumen Systems can also be classified as BURs. These systems usually have a 1-2 ply base and a smooth or granulated cap sheet. The base sheet (s) can be “peel and stick”, adhered with hot asphalt or cold adhesives, and the cap sheet can also be torch applied.

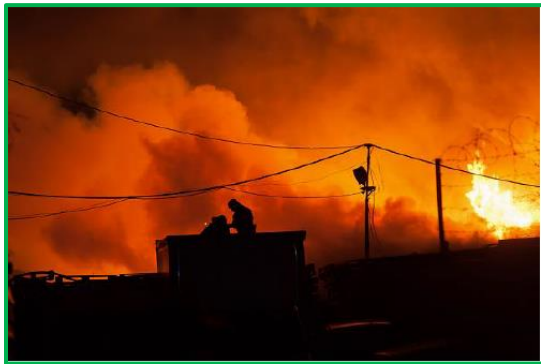
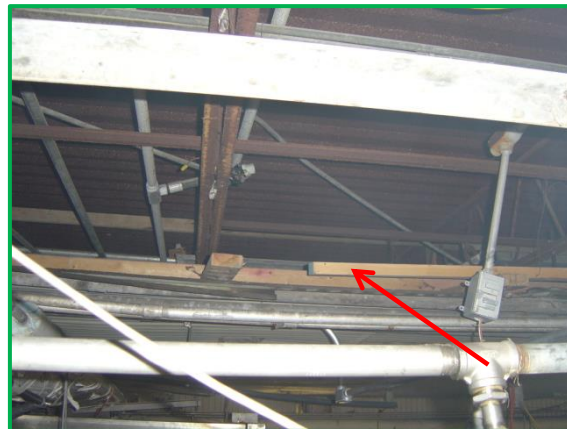
**Torch Applied Case Study #1:** In 2006 in Heflin, AL; “Contractors were working on the roof until late afternoon and the fire broke out shortly after they left for the day.” (Alabama News Report). This resulted in the complete loss of the plant and several million dollars in property losses. As the roofers were applying a tie-in of the new torch applied roof system to the existing one, the open flame was likely drawn below the deck where it ignited the wood supports for a metal panel drop ceiling (see below). The fire in this concealed space (below the metal roof deck and above the metal drop ceiling) worked its way, undetected, throughout a large area of the plant. When firefighters arrived on site the fire was so extensive that it was impossible to save the facility.

*Wood studs were installed to support the metal panel drop ceiling. The wood studs in the approximately 2' high drop ceiling space, and the lack of fire-stopping, would have contributed to the spread of fire within that space.*

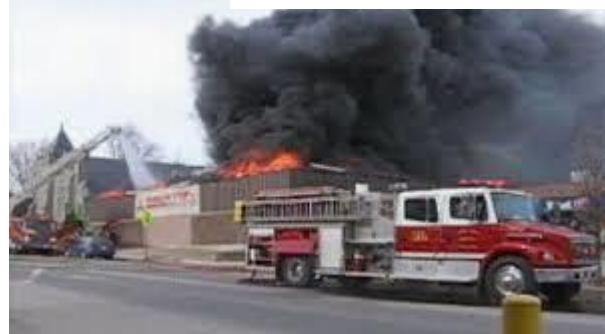
**Torch Applied Roofing Case #2:** A contractor was re-roofing a Dollar Store on March 17, 2011 in Listowel, Ontario. During the installation of a torch-applied roof, a fire started below the metal roof deck. Combustible material and lightweight construction that was not visible fueled the fire which was masked by a drop ceiling. Investigation revealed that the fire may have been burning for up to 40 minutes before 911 was called. These conditions were only discovered when the firefighters started battling the fire. Tragically, as the call was made to vacate the property, the roof collapsed, resulting in two firefighter fatalities.

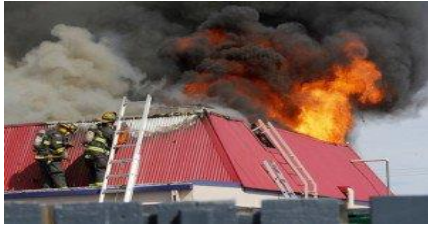
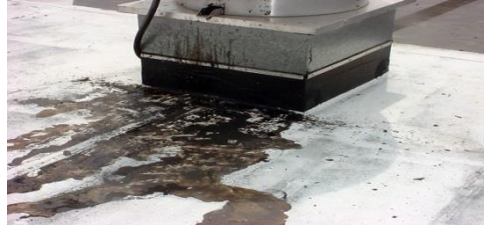
According to a 2012NFPA report<sup>3</sup>, 'grease related hood/duct system fires cost restaurant owners approximately \$50MM USD per year. One in five fires indicated "failure to clean" as a contributing factor.

- Fall hazards
- Damage to many types of roof systems
- Fire hazard
- Environmental contamination

- Regular duct/hood cleaning
- Test duct/hood fire-extinguishing systems per standards (NFPA 96)
- Install and maintain roof top grease collection systems
